Anchorage behaviour and development length of headed bars in exterior beam–column joints

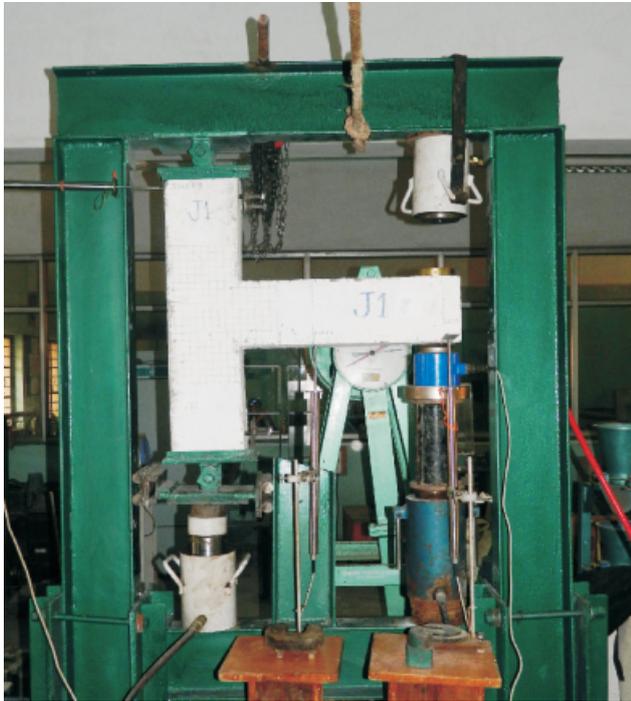
Figure 3. Test set-up

The specimens were tested in a reaction frame. The test set-up is shown in Figure 3. Each of the test specimens was subjected to cyclic load reversals to simulate earthquake loadings. A 1000 kN capacity calibrated hydraulic jack, mounted vertically on the frame, was used to apply axial load on the column. A constant load of 100 kN, which is about 20% of the axial capacity of the column, was applied to the columns to hold the specimens in position and to simulate column axial load. Another two 500 kN capacity hydraulic jacks were used to apply reverse cyclic loading. The load was applied at a distance of 50 mm from the free end of the beam face. The load was measured by inserting a load cell between the jack and the beam face. The test was displacement (drift ratio) controlled and the specimen was subjected to an increasing cyclic displacement, where the drift ratio (DR) is defined as the ratio of deflection Δ of the load point to the distance between the load point and the centreline of the column. Figure 4 shows the loading history in terms of applied cycles plotted against storey drift ratio. The deflections were measured by linear variable differential transducers (LVDTs) at the beam free end tip (at loading point), at a distance of 200 mm from the beam–column junction.

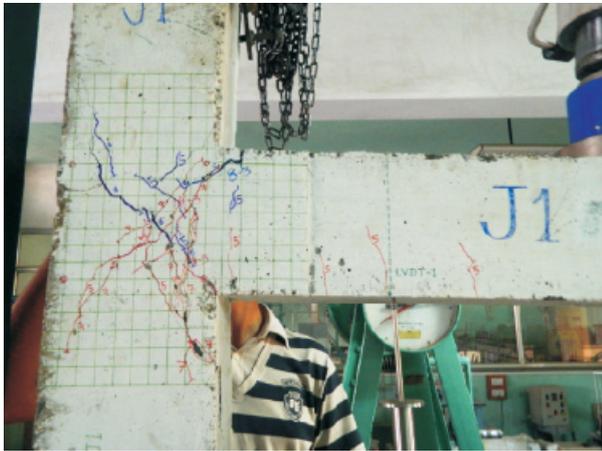
shown in Figure 5. In specimen J1 the initial joint shear cracks appeared diagonally during DR 0.5%, followed by propagation of diagonal cracks up to DR 3%. It did not reach theoretical beam flexural capacity until the end of the test.

Figure 5. Crack pattern of specimens: (a) J1; (b) J2; (c) J3; (d) J4;
(e) J5; (f) J9

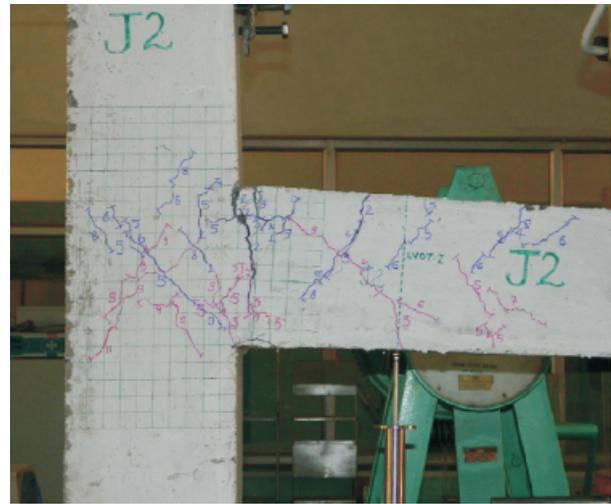
(b)

In specimen J2 initial cracks appeared at the beam interface during DR 0.5%, and these propagated and widened in the subsequent cycles. The diagonal cracks initiated at DR 1% and extended along the diagonal up to DR 4%. Many other cracks also appeared across the joint region.

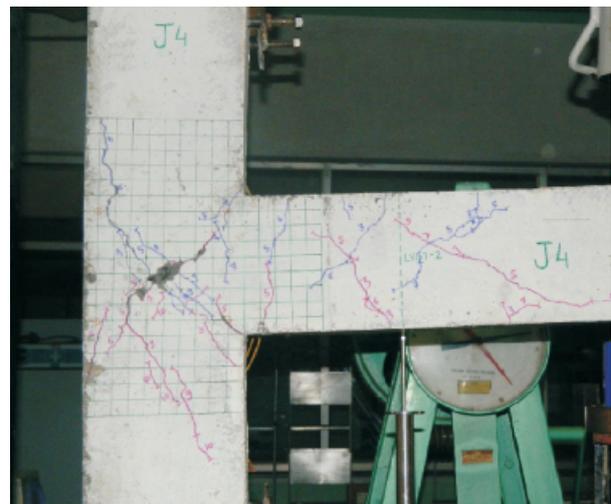
(d)

In specimen J4 all the cracks appeared diagonally at the joint region. No cracks were observed at the beam interface. A typical 'X' cracks pattern was observed, since no joint hoops were provided at the joint. Spalling of concrete was observed during DR 4%.
